PRODUCT SERVICE INFORMATION

Document number: P0004

Vehicle: Holden / Daewoo

Subject: Delco ECM

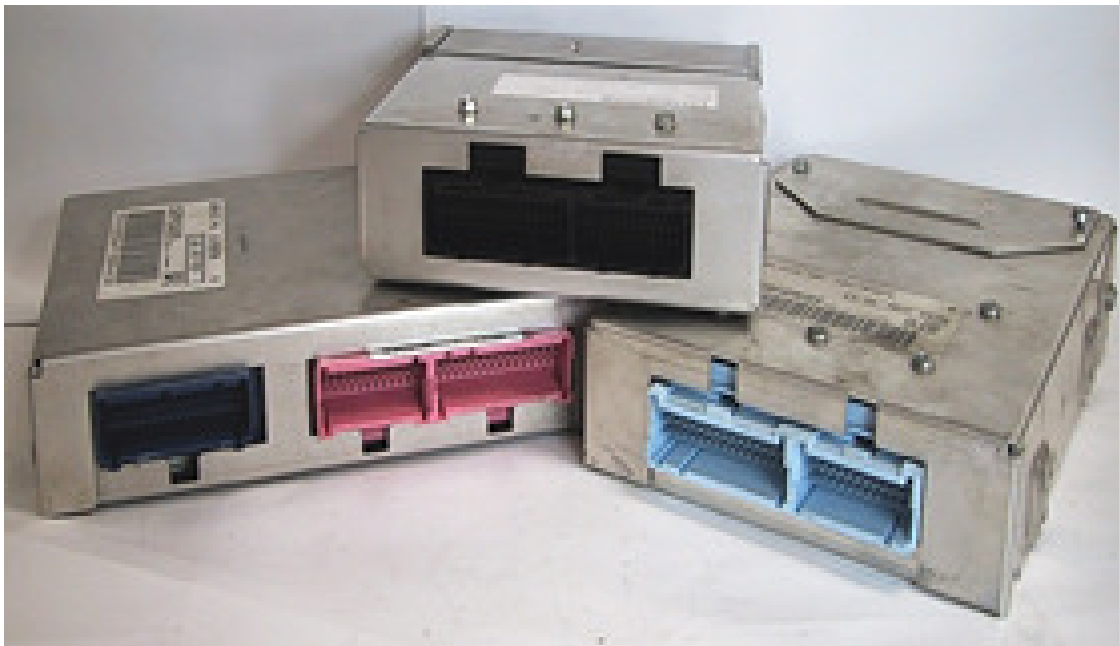
Various Delco Electronic Control Modules and transmission control modules, fitted to a variety of Holden and Daewoo vehicles, are not supplied with a removable Mem-Cal (Memory calibration unit). The Mem-cal from the failed control unit must be carefully removed and installed into the new unit, as per manufacturer instructions. If the Mem-cal is not fitted, faults such as no start, engine thermo fans on, transmission in limp home mode will occur.

After replacing the control module, the unit may require re-learning to the vehicle - check manufacturers specifications before test driving. Please note that intermittent faults with Delco control modules can be attributed to loose / relaxed loom connector terminals (see overleaf).

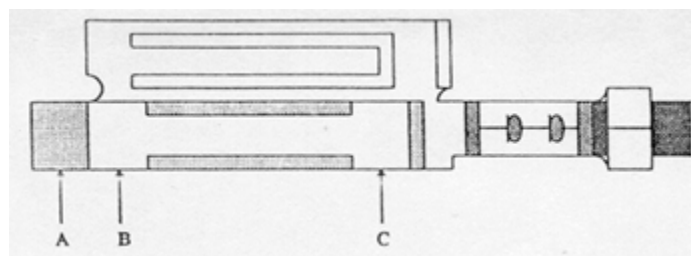
Various intermittent problems have been found on the Delco system and can be traced back to faulty components, such as the wiring, Hall sensors or DFI modules. Some intermittent faults are often attributed to the ECM (some are found to be faulty) and it has also been found that replacing the ECM may solve an intermittent problem but only for a short time. Injctronics has found that often the ECM is replaced and the fault disappears, then after some time the customer is back with a similar complaint. When testing the Delco system it is advisable to do the standard EFI checks and also check the actual connections to the ECM because when the ECM is replaced the connections are disturbed (wiped) and often this may temporarily fix the problem. If any of the terminals are relaxed or oxidised the simple action of unplugging the ECM may temporarily repair an intermittent Delco problem.

Figure 2. Shows the terminal removed from the connector. A is the 0.95mm drill. B & C show where the connector must gently be re-secured to increase the tension on the ECM terminal.

To check individual terminals carefully insert a 0.95mm drill bit into each terminal to ensure that there is a reliable connection between the ECM and the vehicle plug. If any terminals appear to be loose or relaxed, the terminal will have to be backed out of the connector and re-tightened. It is advisable to do each terminal individually, that is back it out of the plug, re-tighten it then re-install into the connector. This is done to avoid any confusion and prevent replacing the terminal into the wrong place in the housing. To remove the terminal from the housing, insert the correct extraction tool and remove the terminal from the rear of the plug. To retighten the terminal once it is out of the housing insert the 0.95mm drill bit, used previously, and very gently re-clip the terminal in the places shown in figure 2. Ensure there is sufficient friction between the terminal and drill shank, remove drill bit, replace the terminal into the housing and proceed to the next terminal.
