PRODUCT SERVICE INFORMATION

Document number: P0043

Vehicle: BMW 1 & 3 series ECM's (2005-2012)

Subject: Water damage

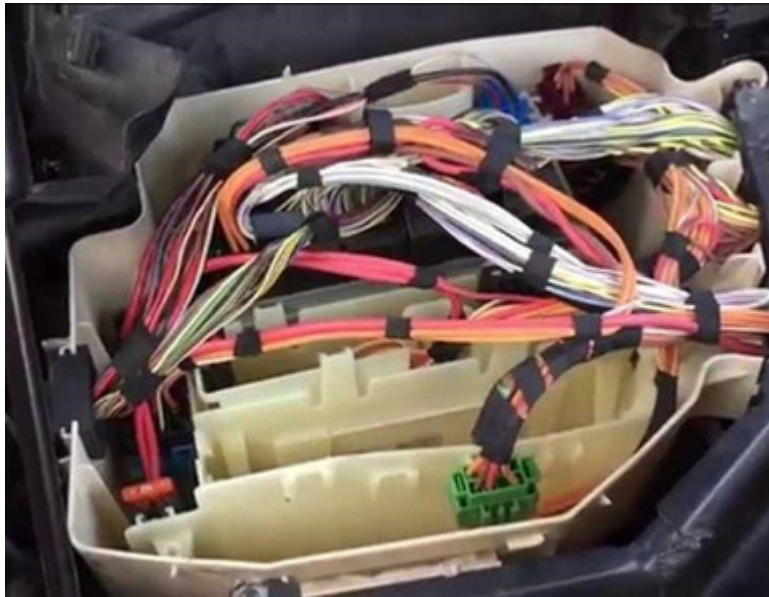
On the BMW 1 series (E87) and 3 Series (E90, E91, E92, E93) from approx. 2004, the ECM is mounted in a E-Box (plastic Box) near the firewall on the passenger side of the engine bay.

Often the reason for water damaged ECM's is a build-up of leaves and foreign mater at the bottom of the windscreen on the passenger side, which in-turn causes the drain port to become blocked.

When the vehicle is washed, or the car is left outside in heavy rain, water will run down the windscreen and overflow into the E-Box. Eventually overtime, corrosion will cause the ECM to fail. This drain must be completely cleared and tested for operation. The E-box drain also needs to be checked for blockage.

When refitting your repaired or exchange engine control module (ECM), it is imperative that you rectify the reason for the water ingress if your ECM failed or was replaced due to water damage.
